HIGH DESERT COMMUNITY Wall & Fence Inventory and Report

PREPARED FOR: HIGH DESERT
RESIDENTIAL OWNERS ASSOCIATION
AND HOAMCO

Prepared by: **pland**
COLLABORATIVE

March 2024

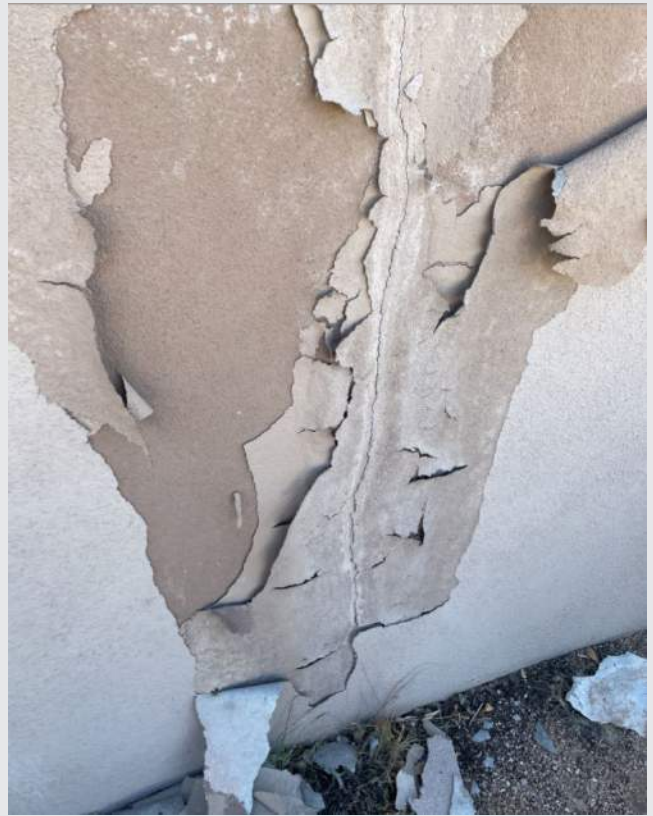
Layers of stucco repair and paint without underlayment

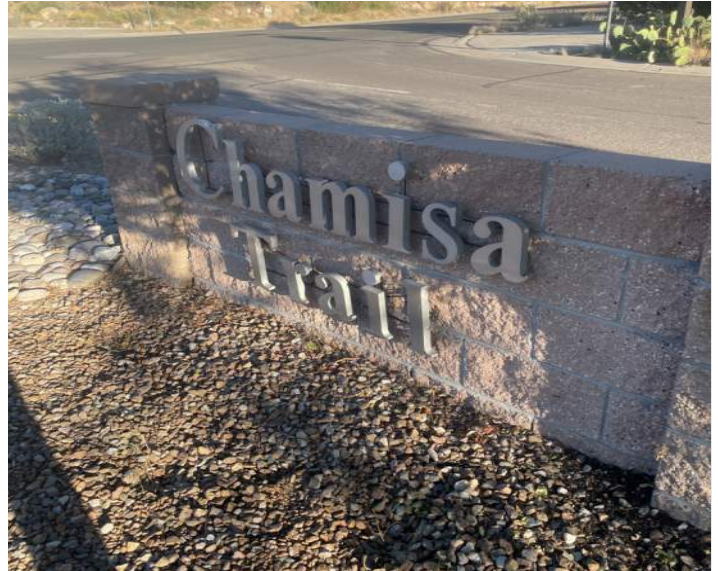
CTM

The Chamisa Trail monument sign is constructed of split-face CMU block and is uncoated. It is in very good condition and was given a Priority 5 rating.

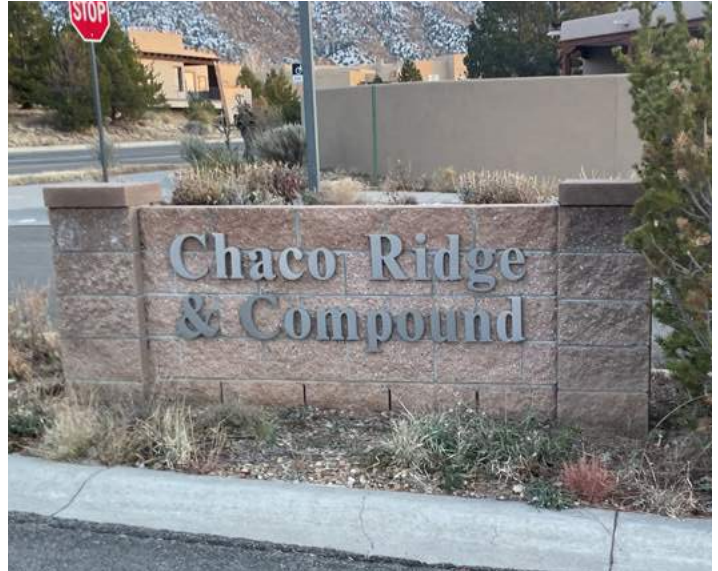
CRM1

The Chaco Ridge monument sign is also in excellent condition (Priority 5), though it showed slight efflorescence on the eastern pilaster, probably due to leaking irrigation.

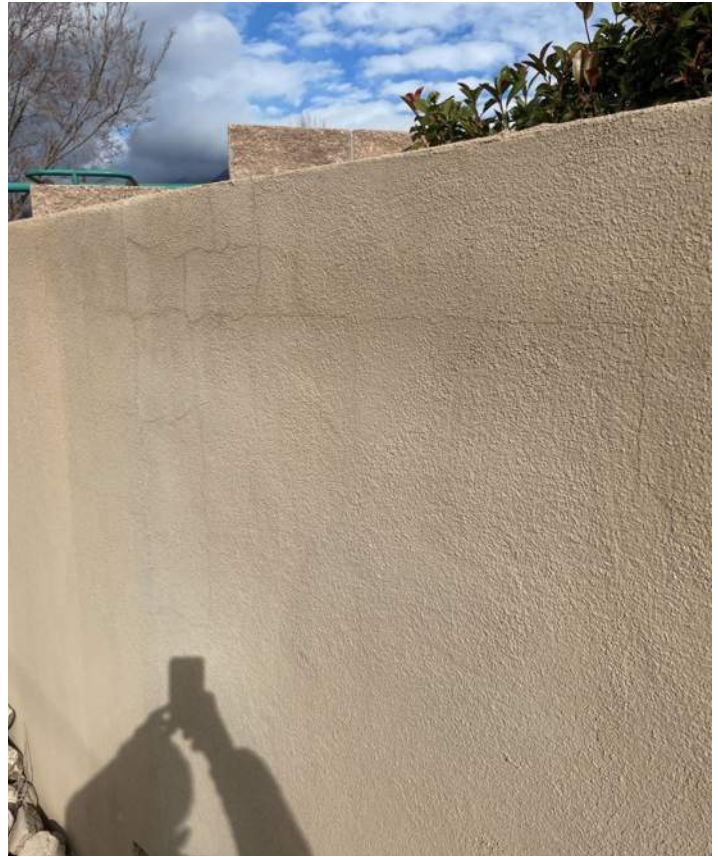
Hairline cracks can be repaired with a fog coat

Next, repair of underlying damage takes place. If cracks in mortar are minor and blocks are still adhered, an acrylic non-sag crack filler is used to coat the surface thereby sealing and weatherproofing any visible cracks. If mortar joints have broken

apart, we recommend using an angle grinder to remove the remaining mortar, cleaning the surface and re-packing and re-pointing the mortar joints.

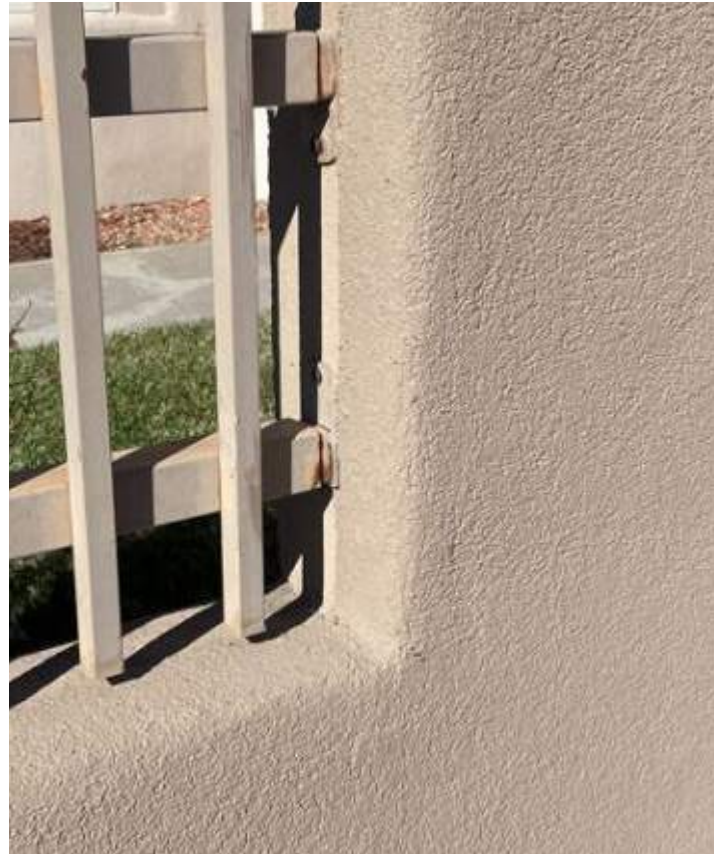
The tube-steel fences in the High Desert development frequently display freeze expansion due to water getting trapped in the vertical pickets which collects and cannot drain. Expansion of the steel causes the painted finish to crack and rusting and degradation to occur. As a minimum solution before re-painting, we recommend drilling a small ~1/8" weep hole in the picket base to prevent this from recurring.

Attachment inserts allow expansion/contraction

When tube-steel fences are replaced, we recommend that care be taken to install the fence panels so that the pickets have open bottoms allowing them to drain.
